# **KENDUSKEAG EAST CSO STORAGE FACILITY IN BANGOR, MAINE**

**JOHN L. MURPHY, P.E.  
JAMES D. RING, P.E.**

**CITY OF BANGOR, MAINE  
ENGINEERING DEPARTMENT**

PAPER PRESENTED AT WATER ENVIRONMENT FEDERATION ANNUAL CONFERENCE -- WEFTEC 2001  
ATLANTA, GEORGIA, OCTOBER 16, 2001  
AND AT  
NEWEA ANNUAL CONFERENCE, BOSTON, MASSACHUSETTS. JANUARY 30, 2002

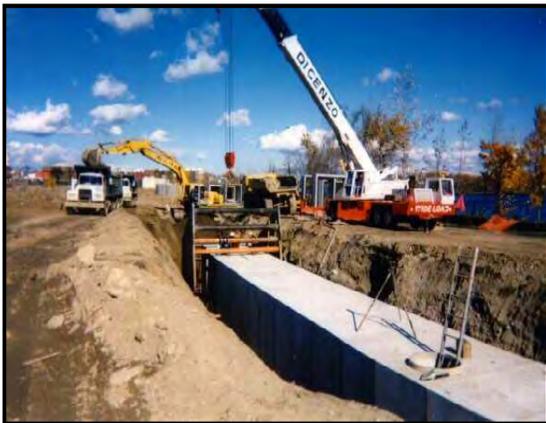
**Figure 1**

In 1998, Bangor constructed the 1.2 million-gallon Davis Brook CSO Storage Facility, a unique and innovative tunnel-like structure constructed of pre-cast concrete box sections and located under a future waterfront park area (See Figure 1). The project was a radical departure from the conventional storage tank approach, and was extremely successful from a construction and operational perspective, and very cost-effective with a construction cost at about \$1.3 million. The Davis Brook project has generated a lot of interest with CSO communities and their consultants.

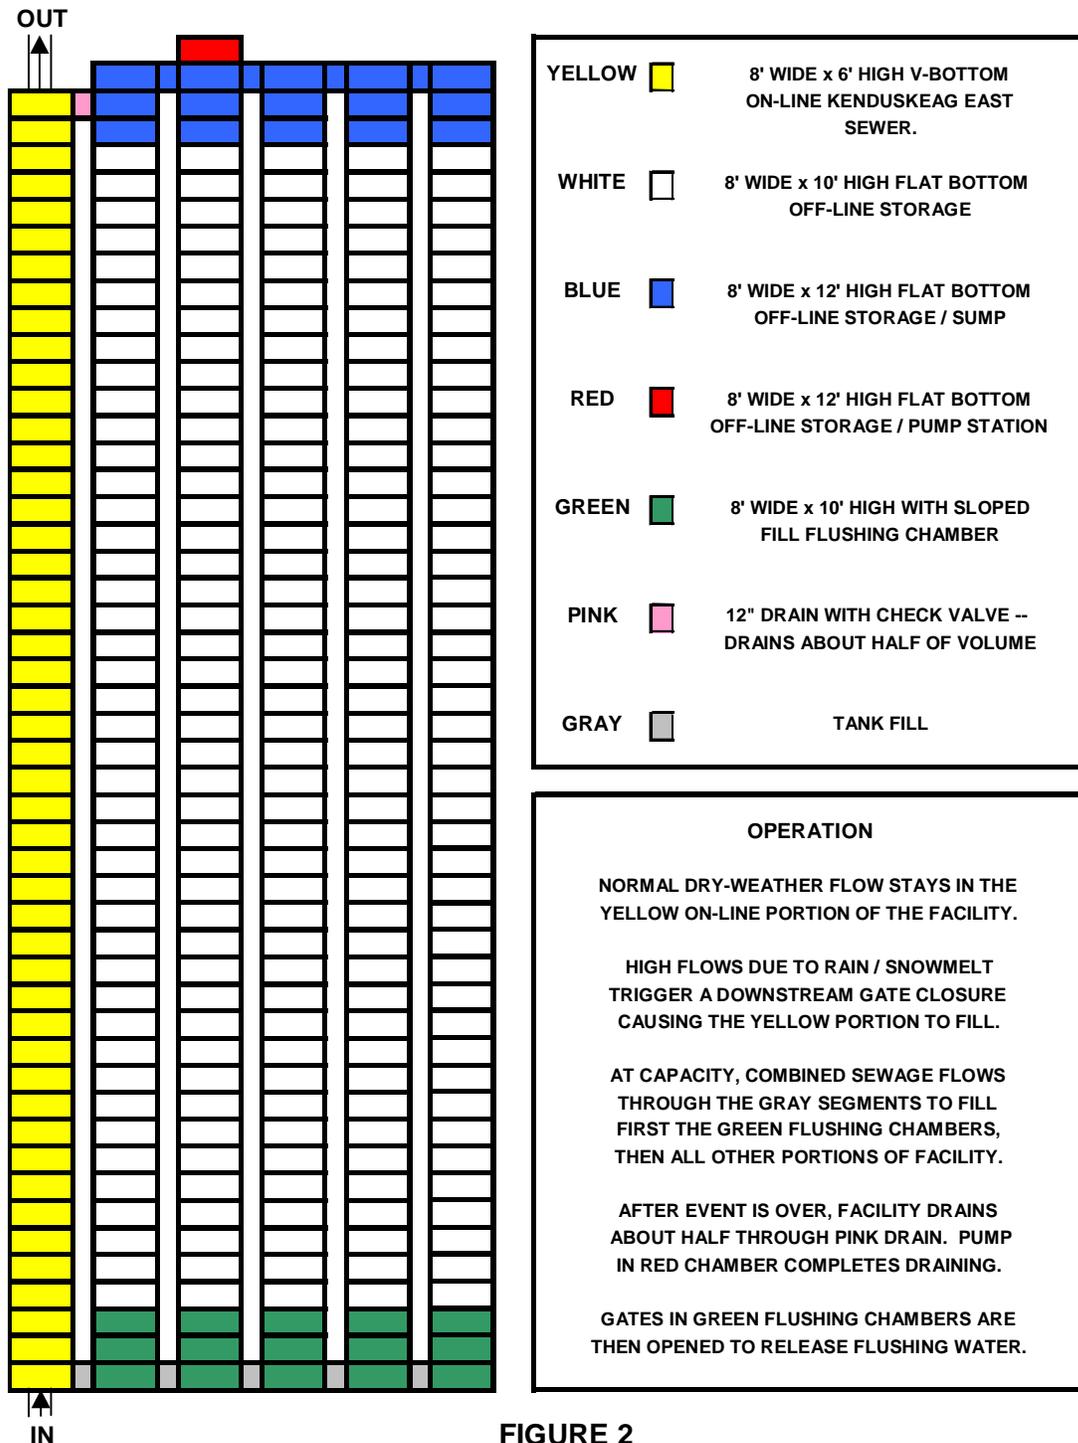
**FIGURE 2**

The existing 42" interceptor on the project site was replaced with 8' wide by 6' high box sections with a V-shaped bottom to maintain velocity over a wide range of flows, thereby minimizing solids deposition. This portion of the project is on-line at all times, and is depicted by the yellow sections shown in Figure 2.

At the low end, each row has three sections sized 8' wide by 12' high by 5' in length, depicted by the blue sections in Figure 2. The end pieces are connected together with 3' by 3' box sections to create a common header. An additional 12' high section, depicted by the red section in Figure 2, provides space for a small duplex pump assembly. These 12' sections are partially filled with concrete that slopes toward the pump assembly for proper drainage. The partial fill also creates a sum that minimizes backwash from the flushing procedure described below.

At the high end, each row has three sections sized 8' wide by 10' high by 7.5' in length, depicted by the green sections in Figure 2. Each third section from the end has a 6'-7" high wall with a Grande-Novac Hydrosel self Flushing Gate assembly installed. There is concrete fill in each row that slopes from zero at the gate wall to 2'-7" high at the end wall. The resulting chamber holds approximately 6,000 gallons to be used to flush out each row following a storage event. The flushing chambers are connected together with 8" pipes installed with a check valve that allows one-way flow.

The rest of the precast sections are 8' wide by 10' high by 7.5' in length, depicted by the white sections in Figure 2. These sections have flat bottoms, which were recommended as most appropriate for the flushing operation.

The off-line portion consists of five rows of box sections. Each row is 360 feet long, 8 feet wide inside dimension, and spaced one-foot from the adjacent row.

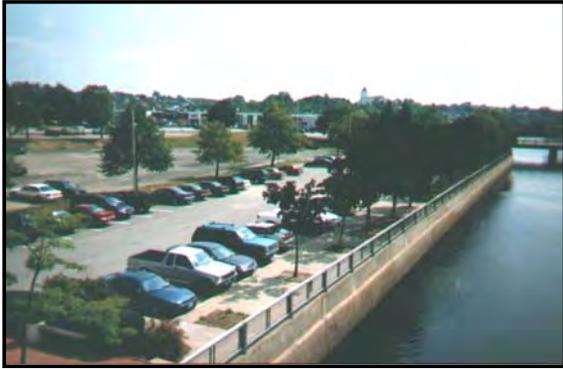
**Figure 3**

The Kenduskeag Stream flows in a channel formed by concrete retaining walls in the downtown area of Bangor. Directly adjacent to the retaining walls on each side of the Stream are public parking lots. The project is located on the east side (See Figure 3).

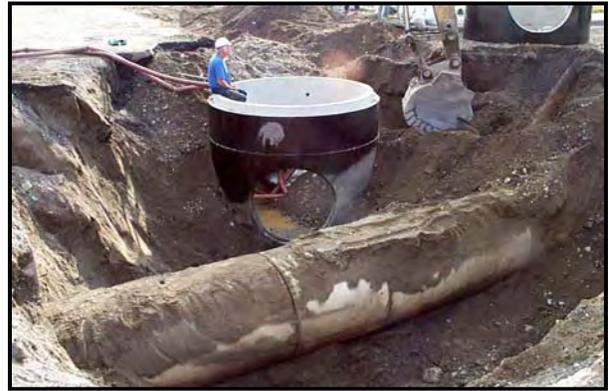
**Figure 4**

Bisecting the parking lot is the 42" Kenduskeag East Interceptor Sewer. (See Figure 4) The presence of this sewer required the contractor to install a temporary relocation (we used the word "bypass" on our drawings, but since "bypass" is already a designated EPA word with an explicit meaning, we use "relocation" here) to an adjacent vacant lot. Next, the vacant lot was paved and striped, and the users of the parking lot were relocated to that area while the CSO Storage Facility was constructed.

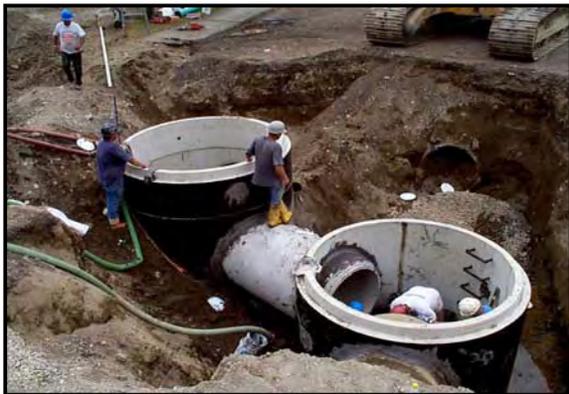
**Figure 5**

Two eight-foot manhole structures were installed at each end of the project site (See Figure 5). Initially, these structures were used to direct the interceptor flow to the temporary sewer.

At the completion of construction, these structures were modified to direct flows into the on-line portion of the Kenduskeag East CSO Storage Facility and to connect the project back into the existing interceptor sewer.

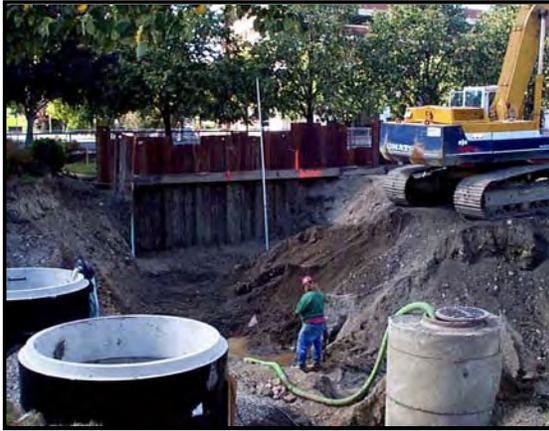
**Figure 6**

A major preliminary construction activity was the installation of a row of sheet piling on the stream side of the parking lot. (See Figure 6) This was done to protect the row of trees between the project and the stream, to provide protection for workers in the excavation, and to help address seepage from the stream into the excavation. Dewatering the site, with the Kenduskeag Stream and its thirteen-foot tides only a few feet away, was a requirement. The Contractor's plan was to install well points at the lowest elevations; however, the well points wouldn't penetrate into the subsurface strata. Instead of well points, the contractor installed a series of vertical culverts in crushed stone lined sumps, each with a pump.

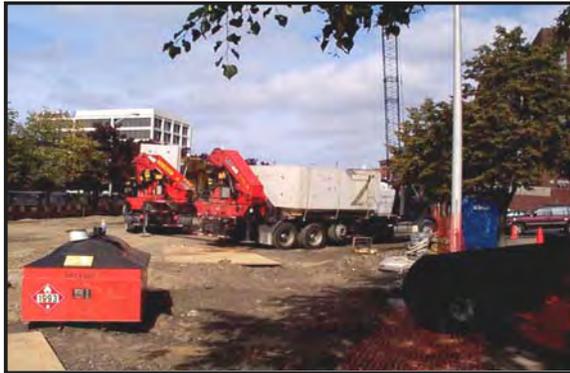
**Figure 7**

One of the drawbacks to the project site was the almost total lack of on-site storage space. The City's contract with American Concrete Industries specified interim storage at the manufacturer's location and carefully coordinated delivery schedules with the general contractor S. E. MacMillan Company. The first precast sections arrived on site on October 2, 2000 (See Figure 7). After the first few deliveries on an as-needed basis, the precast contractor began night deliveries of those units that were planned for the following day.

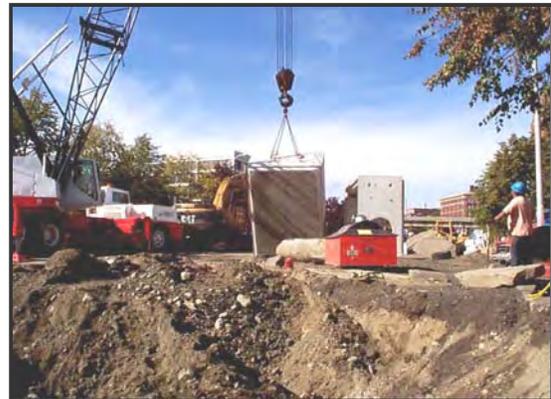
**Figure 8**

The weight of the precast sections (in the 30,000-pound range) required a large crane to lift and set the sections (See Figure 8). At this point of time, the contractor had excavated a 25' long area to subgrade and had installed 12" of crushed rock. The crushed rock was spread and brought to proper grade for the installation of the box sections. The first sixteen sections installed were twelve feet high, eight feet wide, and five feet long.

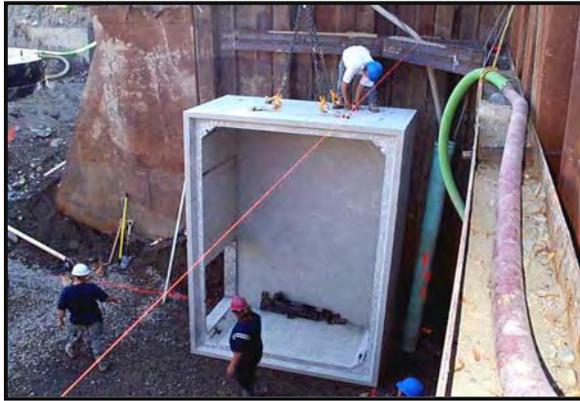
**Figure 9**

It was important that the first section installed (See Figure 9) was placed with correct location, grade, and alignment. The contractor took great care to assure that it was in the correct position. The first row sections were cast with an integral solid end. A square hole in the sides of the end units allowed installation of a short piece of 36" square box section to the adjacent row to create the common header at the lower end. The common header allowed the facility to maintain equal water levels in all rows.

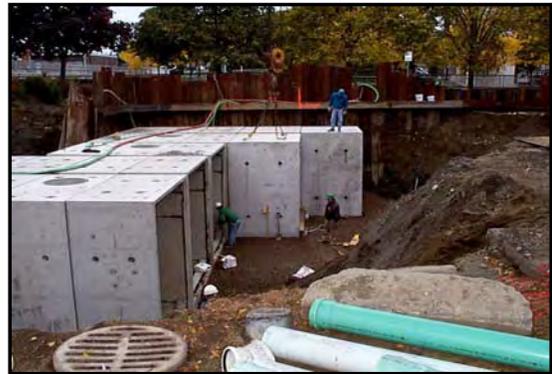
**Figure 10**

Figure 10 shows the installed 12' high sections and the first few 10' high sections. Most of the remaining box sections were 8' wide by 10' high (inside dimensions) by 7.5' long. Due to the weight of the units (30,000 pounds each) and the reach limit of the crane, the excavation could only proceed about 25 feet ahead of the boxes, space enough for three sections longitudinally. Once a routine became established, the excavation took place in the afternoons, with the removal of approximately 700 cubic yards of material, which was trucked about half a mile away to a stockpile site. The bottom foot of the excavation was filled with crushed stone, spread and leveled to grade. The following morning, the contractor could install as many as 15 boxes, depending on weather and other conditions. When finished, the crane was moved out of the way, and excavation began for the next 15 boxes. During the first week, 40 of the 10' boxes were installed.

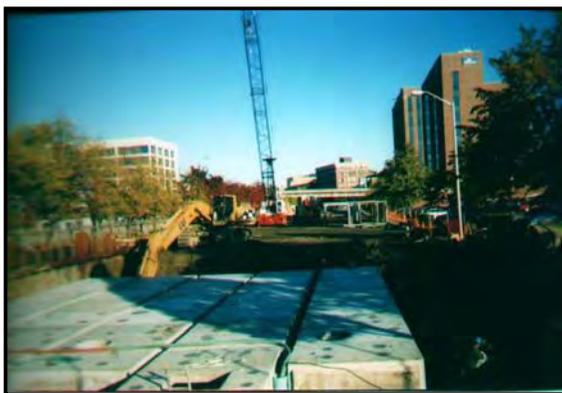
**Figure 11**

The rows of boxes were spaced 12" apart. This allowed each row to be aligned independently and to address minor deviations in fabrication and grade. Figure 11 shows the excavator digging, the crane set back out of the way, and several installed box sections with the required 12" spacing.

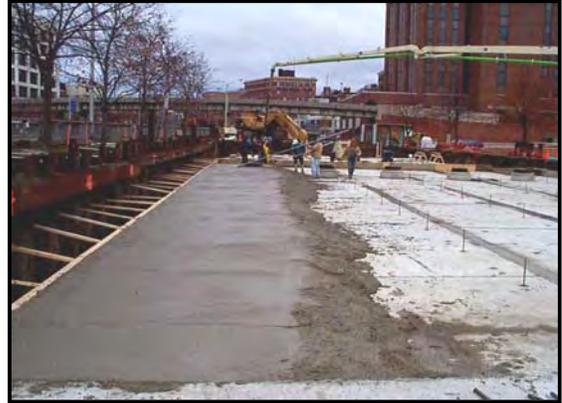
**Figure 12**

The issue of flotation was a concern due to the close proximity of the Kenduskeag Stream and the high water table during high tide. This was addressed by pouring concrete between the rows of boxes and by installing a 15" concrete cap over the top of the completed rows. The capping was first undertaken after about one-third of the boxes had been installed, then again after two-thirds, and at the completion. Figure 12 shows one of the capping operations. The work was accomplished using a concrete pump truck. At the completion of the project, the concrete was covered with about 12" of gravel and 3" of pavement to reestablish the public parking lot.

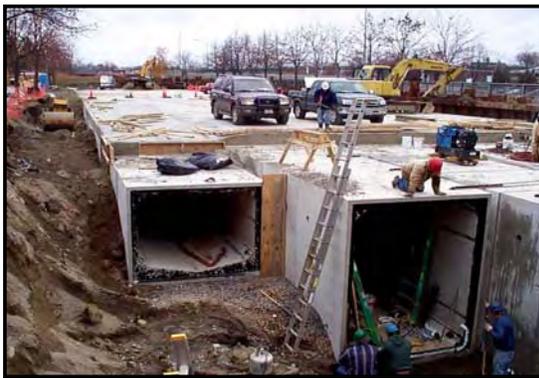
**Figure 13**

Figure 13 shows the 6' high V-bottom on-line portion of the facility (at left) directly beside the first row of the 10' high off-line portion of the facility. The completed cap can be seen in the background with vehicles and construction equipment parked on it. The trees at the left indicate the very tight construction limits of the project. The workers are installing the 1" thick by 4" wide joint sealer on the face of the 10' high box in preparation for the installation of the next section.

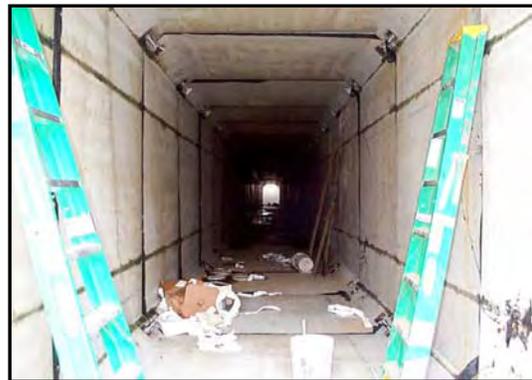
**Figure 14**

The inside of each row of the facility resembles a square tunnel, as can be seen in Figure 14. The bottom is flat with haunches at the corners. There is a joint every 7.5 feet with varying amounts of butyl rubber sealant extruded into the interior of the tunnel. The corners are connected together with threaded rods, washers, and nuts. As the project progressed, all extruded sealer was cut back, the bottom joint was grouted, and the bolt pockets were grouted. Any observed leaks were chipped out and sealed with waterplug. At the conclusion of the project, the interior was smooth and watertight.

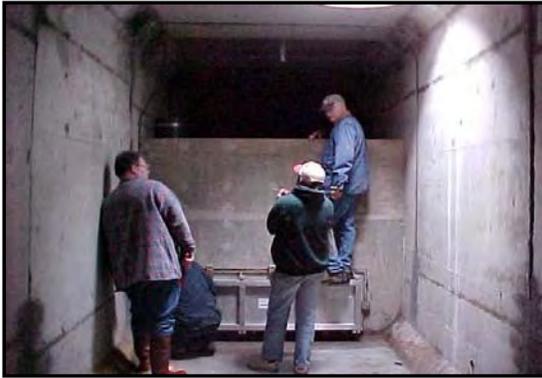
**Figure 15**

Figure 15 is another inside photo showing the flushing gate. On the other side of the 6-foot high

wall is the flushing chamber, which is about twenty feet long with a sloped bottom and a capacity of about 6000 gallons. The gate is hydraulically operated and controlled by the Treatment Plant's SCADA system. Following a tank event, the gate will spring open, releasing the stored flushing water in a surging wave that travels the length of the tank row to wash solids to the pump at the lower end. The controller flushes each row in a timed sequence. The gate closes automatically. Provisions have been made to fill the flushing chambers independently of storm events in case additional cleaning is required.

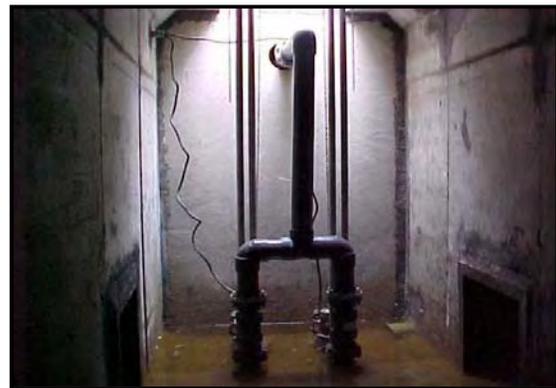
**Figure 16**

At the other end of the facility is the pump chamber. Two five-horsepower submersible pumps, shown in Figure 16, provide the means to fully drain the facility. The pumps are mounted on guide rails, allowing removal for service and preventive maintenance as required. At the bottom corners are the three-foot square passageways to the adjacent rows of the facility. Just beyond the pumps on the right is a 12" pipe that connects to the transducer manhole just outside the pump chamber. The transducer manhole maintains the same water level as the storage facility and has the electronic equipment to measure the liquid level elevation.

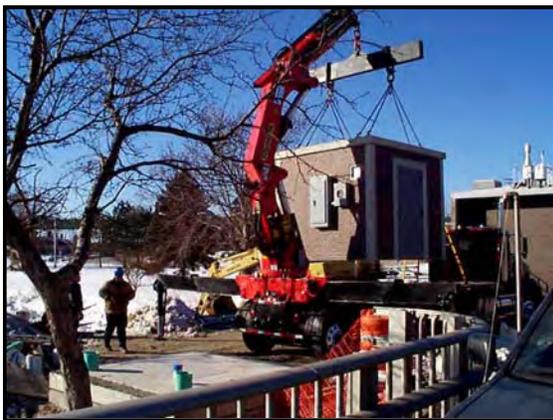
**Figure 17**

Across the street from the CSO storage structure is the Penobscot Interceptor and Kenduskeag Pump Station. Controls for the operation of the CSO Storage Facility are located in two small structures located at the Kenduskeag West and Kenduskeag East CSO discharge structures. Figure 17 shows the installation of a 10' x 10' precast building on the West Side. It is being set on the foundation in the foreground and will house controls for a sluice gate and a transducer to measure tide level. A similar structure was placed at the Kenduskeag East CSO discharge structure for gate controls at that point. Both buildings match the exterior appearance of the existing pump station.

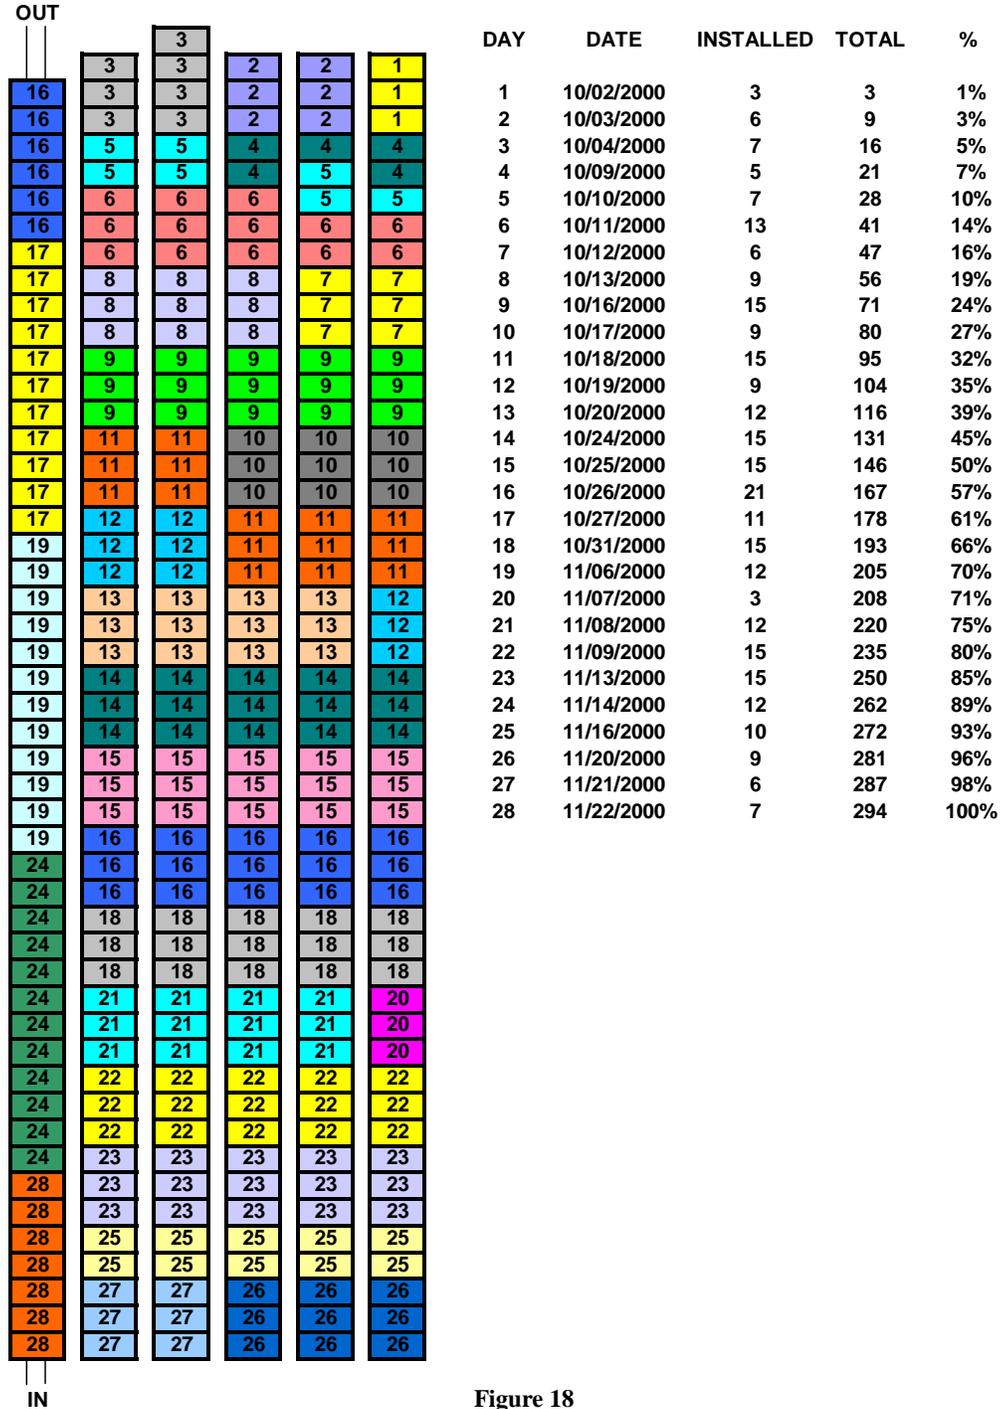
The construction of the Kenduskeag East CSO Storage Facility went very well. Construction began in September and was completed in May, with wastewater flowing through the on-line portion of the facility on May 10, 2001. All precast units were in the ground by November 22, 2000. Figure 18 shows the actual installation schedule of the precast units.
